KZ650 Engine Overhaul - 2

The Examination

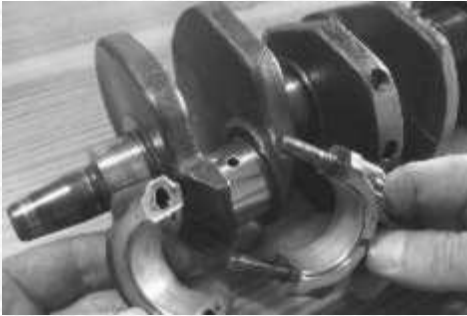
Unbolting the big ends from the crank reveals the old bearing shells. I always replace shell bearings as a matter of course, but the condition of the old shells can give a good indication of the state of the crank itself. These shells are showing typical signs of wear but no undue scuffing, and the big end journals look smooth and polished. The micrometer confirms they're still within factory tolerances.

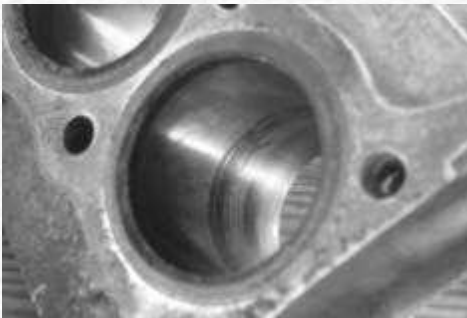
Moving up the engine it's time to take a good look at the cylinder bores. There is some sign of surface corrosion, particularly on No.2 (shown) but as this isn't deep it may not be too much of a problem. I'll be honing out the bores before rebuilding the engine, and as long as the bores are within tolerance afterwards it will be fine. Deep pitting would mean a re-bore.

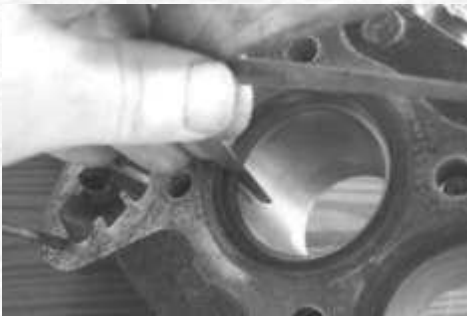
To check piston ring and bore wear I remove the top ring from each piston and gently insert it a few millimetres down its respective bore. The gap can now be checked with a feeler gauge. The factory service limit for this engine is 0.7mm, this one measures 0.6mm. Fitting the ring at the bottom of the bore and measuring again gives me a reading of 0.5mm, indicating the bore is worn by 0.1mm, hardly enough to warrant the expense of a re-bore. As the rings are still within service limits I could re-use them, but I'd rather fit new if the budget permits.

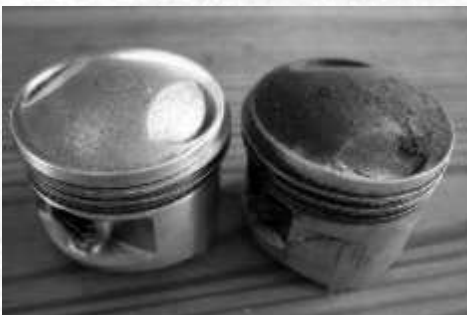
A few minutes with steel wool and aluminium cleaner cleans up the pistons nicely, and scraping with an old piston ring cleans out the ring grooves. Unless there's obvious damage to the pistons it's rarely necessary to replace them unless re-boring the engine. These pistons are still the standard size, which means the barrels could be bored at least twice in future should it ever prove necessary.

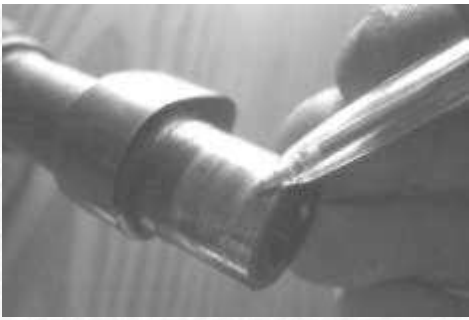
Moving higher up the engine the first sign of a potential problem is found. On this Z650 the cam bearings are machined straight into the head, which means the cams run direct in alloy. The integrity of the cam bearings therefore depends on a constant supply of clean oil and if oil changes are missed or foreign bodies allowed to enter the engine these bearings will suffer first. Some of the cam bearing journals are showing signs of scoring.

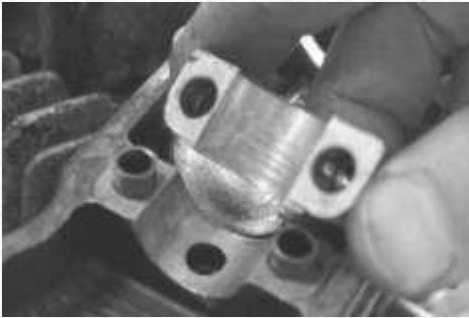
The matching bearings in the head also show some signs of wear, and I'm reserving judgement on these until I've had the head down to a specialist engineering company for a second opinion. If these bearings get too sloppy oil pressure across the whole engine will drop, which leads to a vicious circle of rapid engine wear. The recommended cure is to fit a new head and cams, which would be outrageously expensive, so if necessary we may be hunting for some second hand bits.

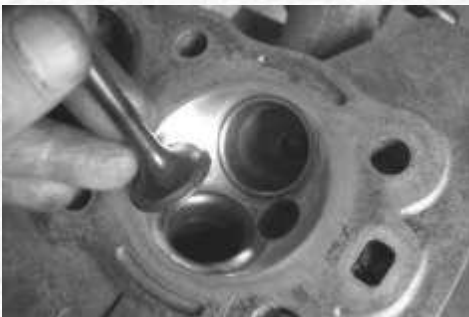
With the buckets lifted out the valves all release with a conventional valve spring compressor, though the limited space around the valve top collar means some compressors sold for car engines will not fit. There is some carbon build up on both the combustion chambers and valves, but both clean off fairly easily. The valve seats themselves look in surprisingly good condition, with only very light pitting on the sealing faces.

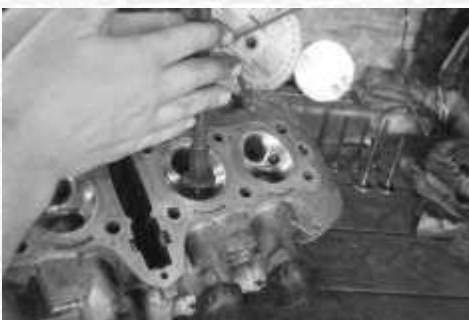
Many engines have pitted valve seats, and it has become almost a matter of routine to send the head out for re-cutting. Engines designed for use with unleaded fuel, like this one, have very hard valve seats which are difficult to lap in by hand. However the pitting is so light on this engine I can use the old fashioned "sucker and stick" method to clean them up nicely. With a little engine oil on the valve stem, I can smear a little grinding paste onto the valve seat, lower the valve into place with the tool and rotate it back and forth on the seat, lifting occasionally to re-distribute the paste. Once the valve seat shows an unbroken matt grey ring I can switch to fine paste to finish off, then clean off all the old paste with petrol. I've removed the old valve stem seals first.

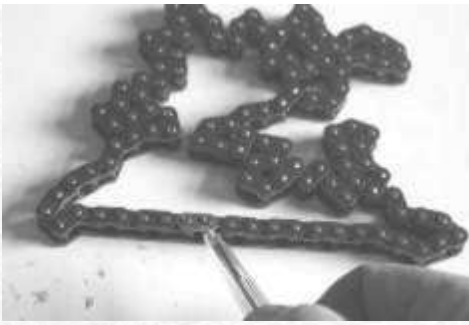
Turning now to the other main engine components, the cam chain is next in line for scrutiny. This cam chain shows obvious signs of wear without having to measure it, and I will be fitting a new one as a matter of course. This cam chain has also had a soft link fitted at some point (shown), probably an indication that it has been replaced without stripping the engine. Factory cam chains are endless, and the engine has to be stripped to fit them. There's nothing inherently wrong with soft linking a cam chain if its done properly, but I like to have endless chains in my engines and this is a good opportunity to swap it.

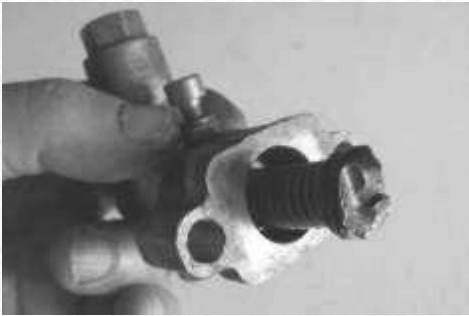
The cam chain tensioner is rather suspect. I noticed that the original 6mm mounting bolts had been replaced with 8mm studs, a sign the tensioner had been removed several times in the past. I suspect this tensioner may be from a later engine as early Z650s used a single plunger type, and this twin plunger tensioner is usually found on later Z650s and Z750s. Certainly the rubber pad on the end of the main plunger looks badly chewed up, perhaps not a major problem in itself but something I'd want to replace.

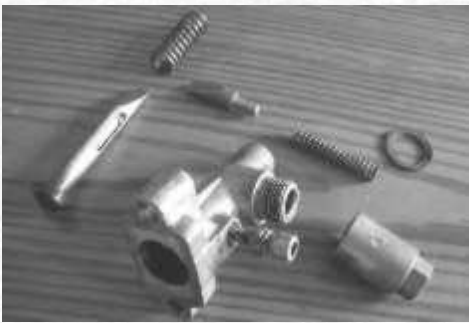
Components of the cam chain tensioner. Kawasaki revised this design at least three times to try and make it work properly. In theory the main plunger can advance inwards to take up slack as the chain wears. The secondary plunger then moves across at ninety degrees to lock the main plunger in place, and stop it moving backwards. Wedge ends on the plungers supposedly lock the two together. In reality the two plungers frequently chattered against each other, burred up the wedges and left the cam chain to its own devices. Kawasaki added progressively longer springs and end caps to fix it, but many owners converted the tensioner to manual operation by simply adding a pinch bolt and locknut to hold the main plunger in the tensioner body. This one has been so converted, but the bolt is the wrong size to engage with the slot in the plunger and has made matters worse.

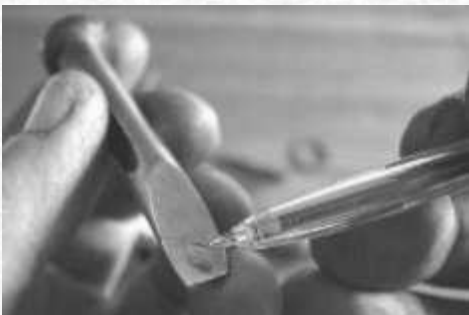
This is the type of burring you usually find on the plunger ends. You can theoretically clean these up with a whetstone and re-use them, but once they've got this bad both plungers will have to be replaced. It may be a bit "belt and braces" but I'd also prefer to convert the tensioner to manual operation too. This does mean it will have to adjusted by hand at each service; not a major job but easily overlooked if the owner assumes the tensioner is still automatic.

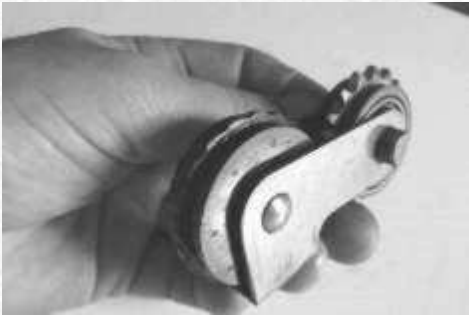
Early Z650s used a combination of sprockets and rubber idler wheels to guide the cam chain run, later replaced in favour of simpler slipper blades. This is the main guide roller assembly which fits at the rear of the barrel and is pivoted by the cam chain tensioner. The rubber roller has hardened with age and worn dimples around its working face, and I'll be fitting a new one. However this may not be a cheap option.

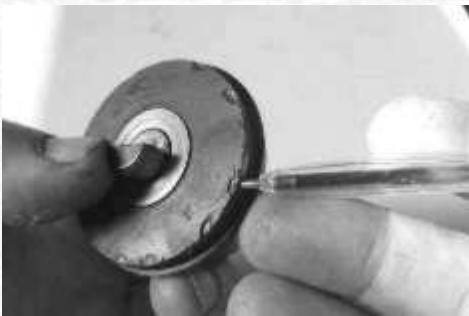
This rubber guide wheel, also from the cam chain, is showing signs of breaking up around the working edge. It's also become quite hardened and brittle compared to a new one, so it goes on the list for replacement too.

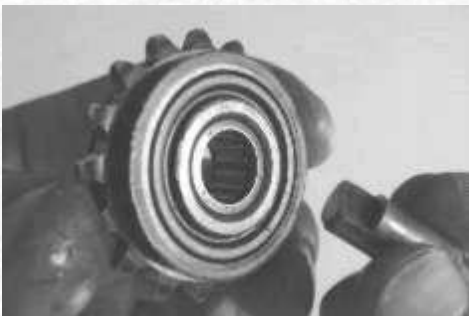
And this is one of the cam chain guide sprockets. These are supported in tiny needle roller bearings and it's as well to check to make sure the rollers are intact, as they are here. Note the flats on the end of the bearing pin - these are sandwiched against tiny rubber blocks between the head and barrel which also harden with age. Nothing wrong with the sprocket, but I'll be replacing all the tiny rubber blocks.

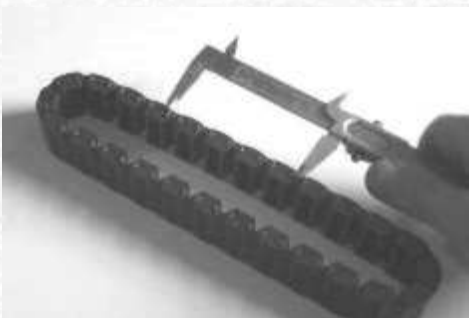
The primary chain is an enormous Hy-Vo device, massively strong but also massively expensive to replace. Kawasaki advise measuring wear by looking for sideways play which should not exceed 27mm, which you can do with the sump removed and the engine in the bike. Here I'm checking for length between the pins. There's no tensioner provided for the primary chain. I'm not surprised, to find this one is well within its service limit.

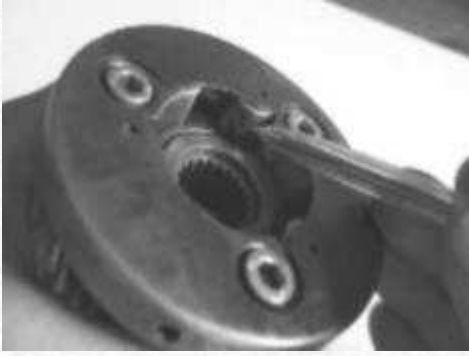
The starter clutch follows conventional Japanese design. These three rollers are fitted in wedge-shaped slots, and held outwards by small springs and plungers. When the starter is engaged the three rollers are wedged against the drive gear to transmit the drive. After high mileages the three rollers can begin to develop flats and may not lock against the drive gear correctly, making the starter spin without turning the engine over. Now is the time to fit new rollers and springs.

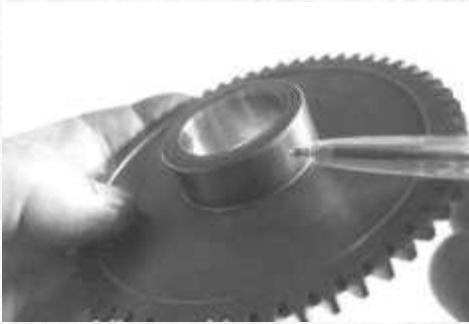
This is the boss on the drive gear which should wedge against the rollers in the starter clutch. Any sign of flatting, or "three-penny biting" on the boss means the starter clutch can slip under load. This one has the first signs of wear and is approaching the end of its service life. Replacing it now may not be the cheap option but it may save another engine strip to change it in a few thousand miles.

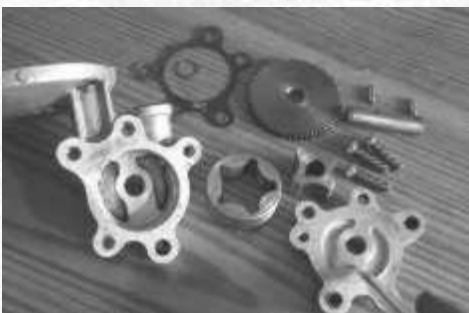
I've stripped the oil pump right down and cleaned it up for examination. I always follow the recommended checks for clearance between the rotors, but I've found the common problem with these pumps is frequently scoring on the endplate (shown). Any foreign bodies in the sump can be drawn into the pump (which is before the oil filter in the system) and go around inside it. Even light scoring here can dramatically affect oil pressure and is worth watching out for. This one has only light polishing, and should be fine.

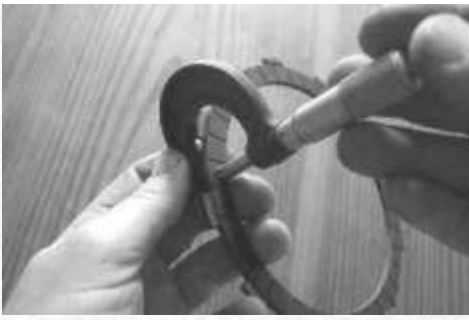
The clutch plates look a little on the thin side. Sure enough when measured they're under the service limit of 3.5mm, and I'll be fitting a new set for the rebuild. Only the friction plates need replacing, the plain plates will have only suffered if they've buckled due to very hard use or racing. Check the plain plates on a flat surface to make sure of course, but under normal use they should last more or less indefinitely.
