KZ650 Engine Overhaul - 1

The Strip Down

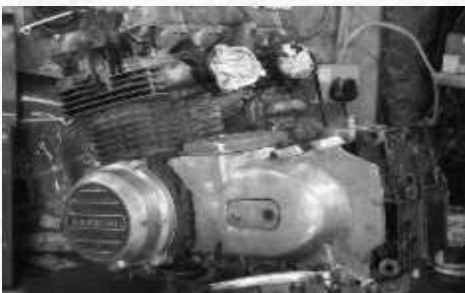
First impressions can tell you a lot about an engine's condition. This one had obviously see service for some years judging by the amount of surface corrosion and dirt embedded in the cylinder fins. With this engine, many of the original fasteners were missing or had been replaced with "hardware shop specials", and the generator cover was not properly fitted which suggested poor maintenance. However it turned over without problems and all the exhaust studs were present and serviceable.

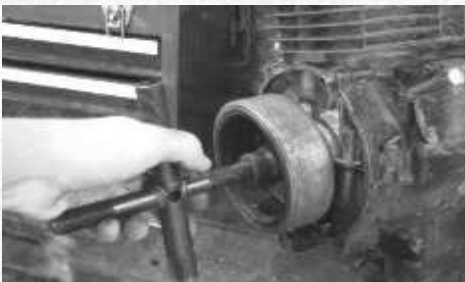
Removing the generator cover reveals the rotor, which should be located onto the crank taper with a large central bolt. This engine had surface rust on the rotor. This rust isn't too much of a problem provided the rotor magnets are undamaged, and the stator (captive in the outer cover) looks in good condition. The rotor came off easily enough with this puller.

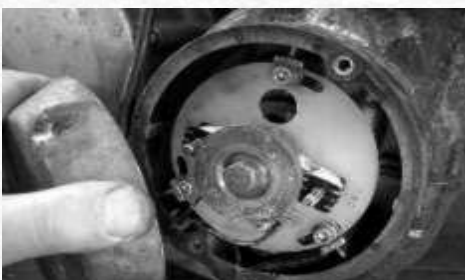
On the other side of the engine, removing the points cover revealed this Boyer electronic ignition kit. Early Z650s had points ignition, and many owners fitted aftermarket kits to replace them.

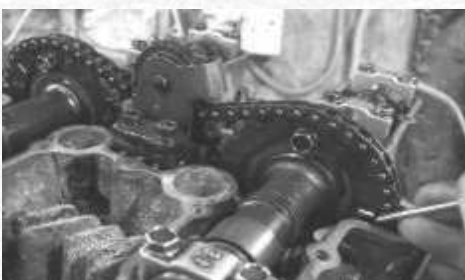
At the engine's top end now, and unbolting the 15 bolts and removing the cam cover reveals the DOHC layout. I have valve timing diagrams but I always make a sketch of the position of the cams before dismantling any engine. With the engine set at 1&4 TDC a timing mark on the exhaust cam wheel (indicated) lines up to the cylinder head flange. Counting back from there, the mark on the inlet cam lines up to the 33rd pin on the cam chain.

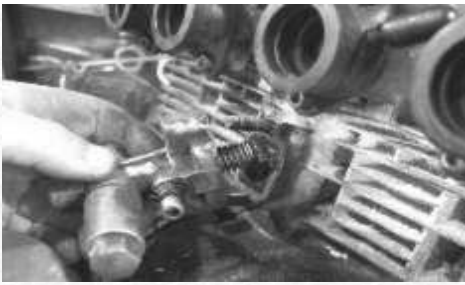
Before unbolting the cams I'm removing the cam chain tensioner from the back of the cylinder block. This is quite safe with the engine set at 1&4 TDC. The tensioner was a bit of an Achilles heel on these engines, and Kawasaki went through several modifications to come up with a reliable design. This late version tensioner has two plungers operating at 90 degrees, but I note the threads on the rear of the cylinder block have been tapped out to 8mm to accommodate larger studs. This may well be an indication of previous problems as the original 6mm threads can strip if the tensioner is removed often.

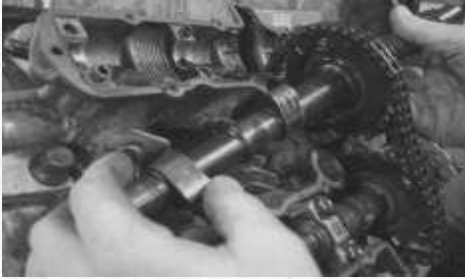
With the tensioner and upper idler wheel removed, I can now slacken and remove all the cam caps in sequence and then lift out the cams. As the engine is being stripped completely I can let the cam chain fall down inside the engine. The cam caps are numbered and must be replaced in their original positions, and each one is located on two dowels which are easy to lose. To keep them all safe I always replace all the cam caps onto the cylinder head and wind the bolts in finger tight.

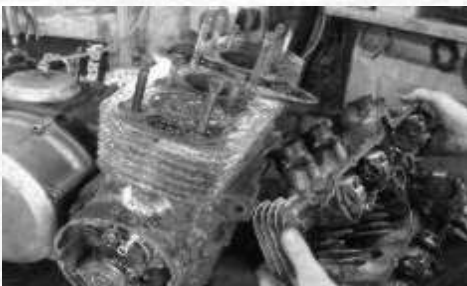
Removing the cylinder head is then a simple matter of unbolting all the head bolts in sequence and gently tapping the head free from its gasket. At this stage I'm laying the complete head aside as an assembly, and will strip the valves, buckets and shims out later for inspection. Note the inlet rubbers which have been fitted the wrong way round, the vacuum take off pipes should face downwards, not up. This won't affect the running of the engine, and someone may have done it purposely to make it easier to fit vacuum gauges for servicing.

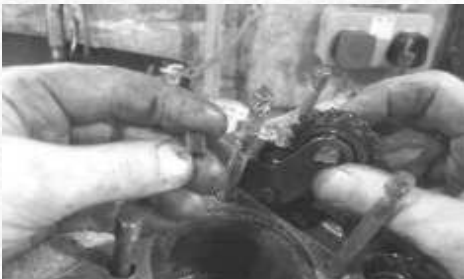
The early Z650s used a collection of rubber idler wheels and sprockets to locate the cam chain, including this pivoted assembly at the rear. The idler wheels run on needle roller bearings supported on short shafts, and each shaft is mounted on tiny rubber blocks sandwiched between the head and barrels.

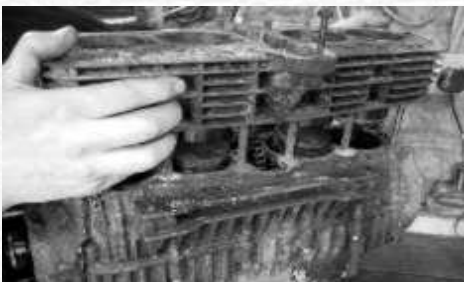
All Japanese engines of this era are susceptible to corrosion at the front of the engine and it's not unusual to find barrels corroded solidly onto the cylinder studs and effectively welded fast to the crankcase mouth. I'm relieved when these barrels move with only a little effort.

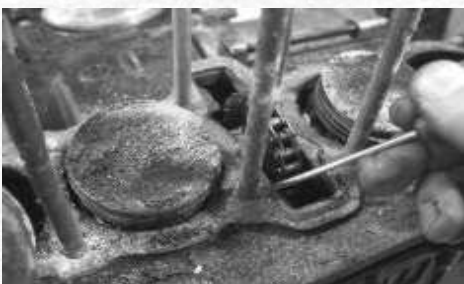
With the barrels off you can clearly see the extent of the corrosion which has built up on the front cylinder studs, and the amount of corrosion / detritus which has fallen into the engine as the barrels came off. Fortunately I'm stripping this engine right down so it can all be cleaned up later, but if this was a top end strip it would be a major headache making sure all this muck had been cleaned out of the engine. The piston crowns look in reasonably good condition, the visible carbon build up is fairly typical of an engine which has done any kind of mileage and should clean up easily later.

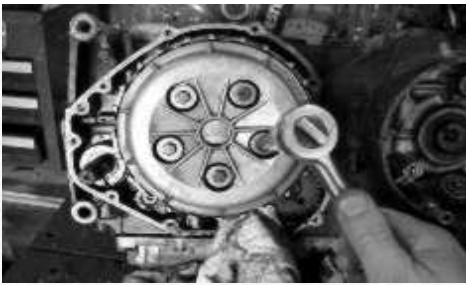
Back to the right hand side of the engine now, and removal of the clutch cover reveals the clutch and kick-starter. The clutch follows conventional Japanese design, and removal of the six bolts allows me to lift out the springs and plates for examination later. To stop the clutch turning as I undo the bolts I've wedged a rag into the primary drive gears at the front of the clutch basket. This is enough to lock the engine for light work like this, but I wouldn't use this method for removing larger bolts on generators or clutch centres.

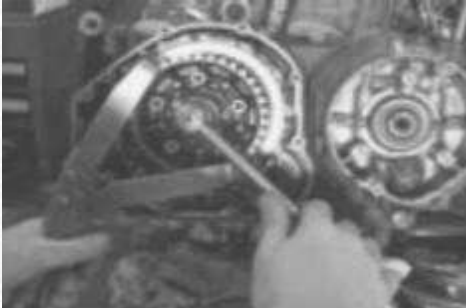
With the clutch plates removed the inner drum is bolted onto the gearbox input shaft with a large nut. The clutch outer basket has a spring loaded shock absorber built into the primary drive gear and this is typically looking rather saggy, the basket wobbling back and forth against the gear. A certain amount of play here is very common (and not too much of a problem) but this one feels a little excessive and will make the transmission feel snatchy. This can be replaced by specialist companies (Klasmo) or a NOS outer clutch basket will need to be found.

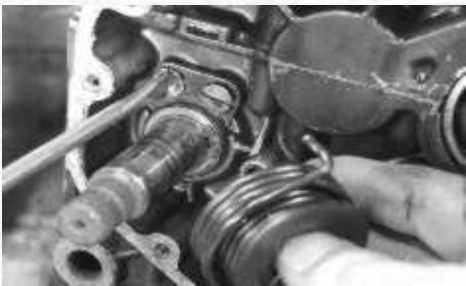
With the clutch removed the kick-starter mechanism is clearly accessible. A slotted nylon boss slides out of the centre of the kick-start return spring, then it's easy enough to hold the spring with long nosed pliers and unhook the spring ends from the stops. This catch plate will have to be removed to detach the kick-start from the crankcase.

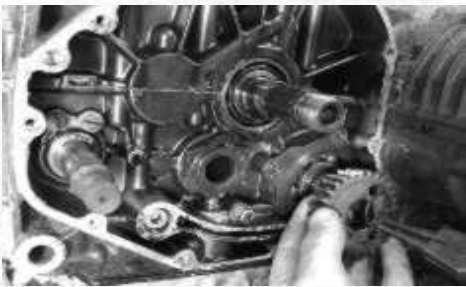
Finally on the primary drive side, releasing this circlip allows the primary drive gear to be taken off the jackshaft and set aside. The Z650 engines were designed with a jackshaft running behind the crankshaft, driven by a huge primary chain buried deep in the crankcase. This primary drive gear links the clutch basket to the end of the jackshaft. This layout kept the physical size of the engine down.

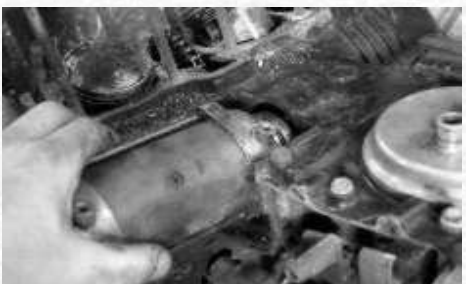
Up top again, and the starter motor unbolts from the top of the crankcase and lifts clear. On these engines the starter drive clutch is also mounted deep within the engine on the jackshaft, rather than on the back of the alternator rotor. Consequently the starter motor is mounted what looks like the wrong way round, with its drive gear facing the centre of the engine. This design keeps the engine compact, but servicing the starter clutch means awkward upwards surgery through the sump or a crankcase split to access the jackshaft.

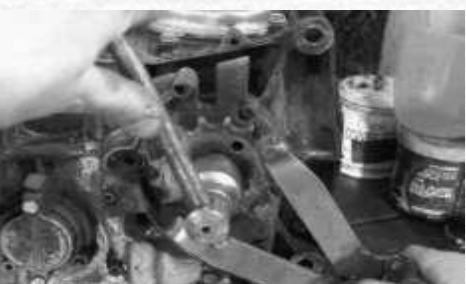
On these engines the engine sprocket has to be removed from the gearbox shaft before the crankcases can be split. If stuck for a special holding tool I've previously used a length of old chain wrapped around the sprocket and clamped in a vice.

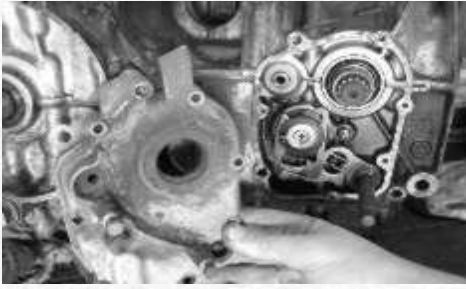
This is why the engine sprocket had to come off. An engine cover (known as a "mission cover") conceals the end of the gearbox shaft and gear selector mechanism. Kawasaki designed the Z650 with a steel guide plate mounted on the mission cover forward of the sprocket. If a chain should break in service it will at worst only damage the mission cover, and not the crankcase itself. This engine has a broken steel guide plate with the top half missing completely. It may accept a helicoil later.

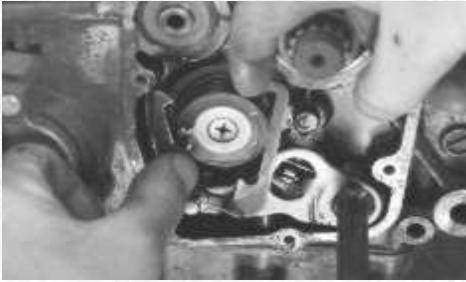
With the mission cover removed the gear selector claw unhooks from the end of the drum and the gear change shaft can be lifted clear. This makes gear change shaft replacement an easy job on these engines, and leaky oil seals can be replaced in the mission cover without having to split the cases.

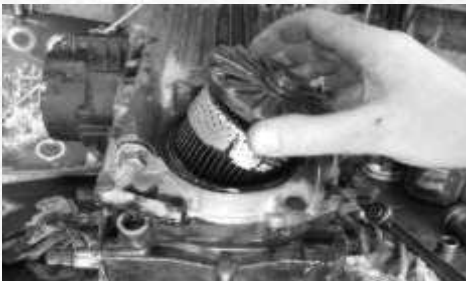
Before splitting the crankcases I've turned the engine over to remove the oil filter and sump. The oil filter bolt should unscrew easily, but can be a problem in real life as many owners were tempted to over tighten them after changing the filter. Consequently over tight bolts with rounded heads are very common.

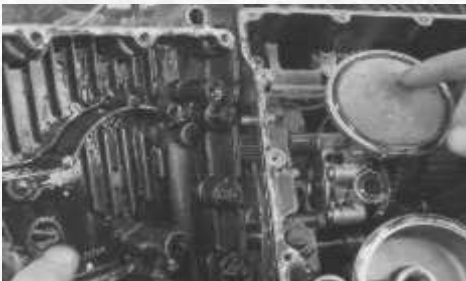
With the oil filter removed the sump can now be unbolted and lifted off. It's always interesting (though rather messy) to poke around in the sump as any signs of metal filing / swarf will say a lot about engine condition. Heavy sludge here will also give an indication that oil changes have been missed. Although rather messy and black, the sludge build up here is quite low and there's no signs of filing or corrosion in the sump. This is a favourable sign for the main and big end bearings. Also check the oil strainer gauze at this stage - sludge, old bits of gasket goo and sundry foreign bodies will all accumulate here and will all help to restrict oil flow to the pump. This one is fairly clean, another encouraging sign.

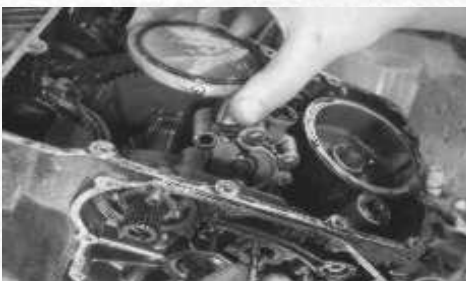
The oil pump is mounted inside the lower crankcase half and held in place with three screws which pass through from the back of the clutch housing. I'll be stripping the pump down later to check for any signs of wear.

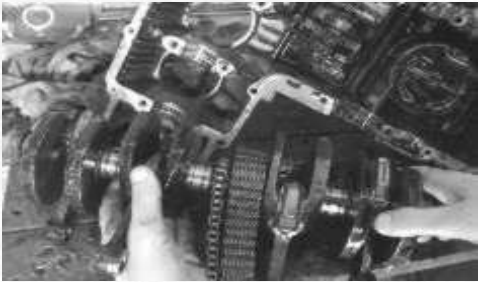
Here's the crankshaft lifted clear. Note the main bearing shells in the crankcase half and the gear selector forks and drum still in place. Still a bit of dismantling to do before I can check everything over but the engine is now in big manageable lumps. And so far, apart from one or two obvious signs of age, it looks to be in reasonably good condition.
