KZ650 Engine Overhaul - 2

The Examination

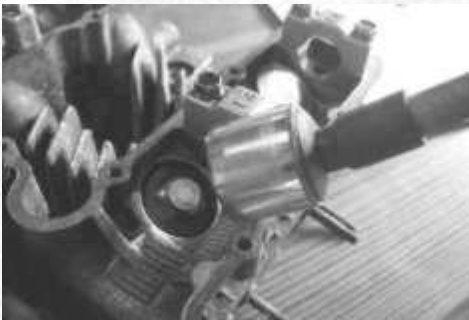
The matching bearings in the head also show some signs of wear, and I'm reserving judgement on these until I've had the head down to a specialist engineering company for a second opinion. If these bearings get too sloppy oil pressure across the whole engine will drop, which leads to a vicious circle of rapid engine wear. The recommended cure is to fit a new head and cams, which would be outrageously expensive, so if necessary we may be hunting for some second hand bits.

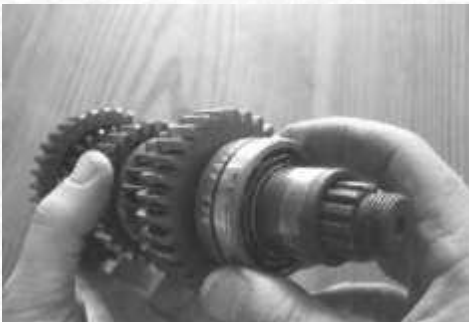
This is the boss on the drive gear which should wedge against the rollers in the starter clutch. Any sign of flatting, or "three-penny biting" on the boss means the starter clutch can slip under load. This one has the first signs of wear and is approaching the end of its service life. Replacing it now may not be the cheap option but it may save another engine strip to change it in a few thousand miles.

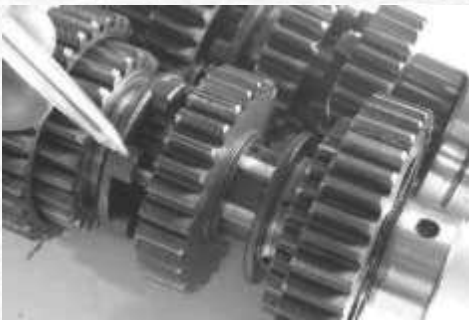
Next in the pile is the gearbox shafts and gears. The Z650 has a strong transmission design and rarely gives problems here, but its always worth checking while its apart. This bearing on the output shaft fits behind the engine sprocket. If the rear chain has been run too tightly it will have put too much load on this bearing. If any signs of wear replace it now, and use a genuine bearing rather than one from a supply shop.
